Case Study

Site Description – Crude oil (bunker C) spill in Sea of Japan

Site Location: Mikuni, Japan

Contaminant: Heavy Crude oil

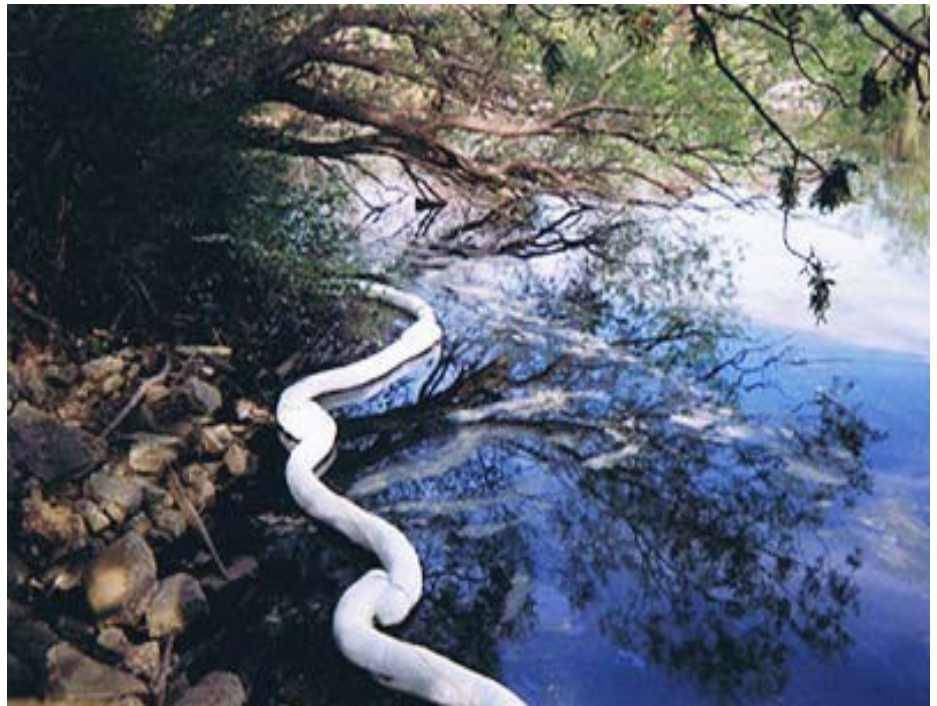
Description of area. The shore line is mountainous and rocky with an occasional small bay with coarse sand and cobble beach. The diurnal tides were approx. 1.6 meters. The area of the site is north of Osaka along the Japanese sea coast in Khyogo, the area of Kasumi, at a small village, Shibayama. The bay was protected by jetties. In front of the town, concrete ramps and piers housed the fishing boats. The shoreline was part coarse sand and rocks. The linear area of the bay edge was approximately 3/4 km.

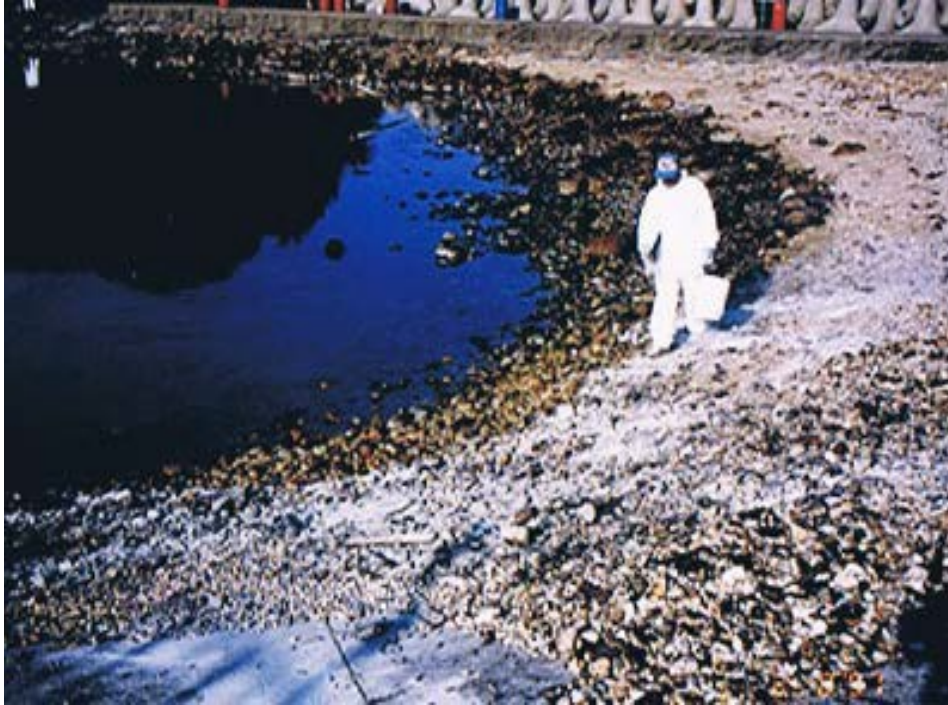
This oil had weathered in a month to dark varnish coatings on the rocks and jetties. Oil was also found on the driftwood and plastics that are brought ashore by storms and deposited high on the beach in the rocks or sand.

One area was highly impacted with both old dark tar-like weathered oil from the initial spill, and light brown platter-like tar patties from newly released oil.

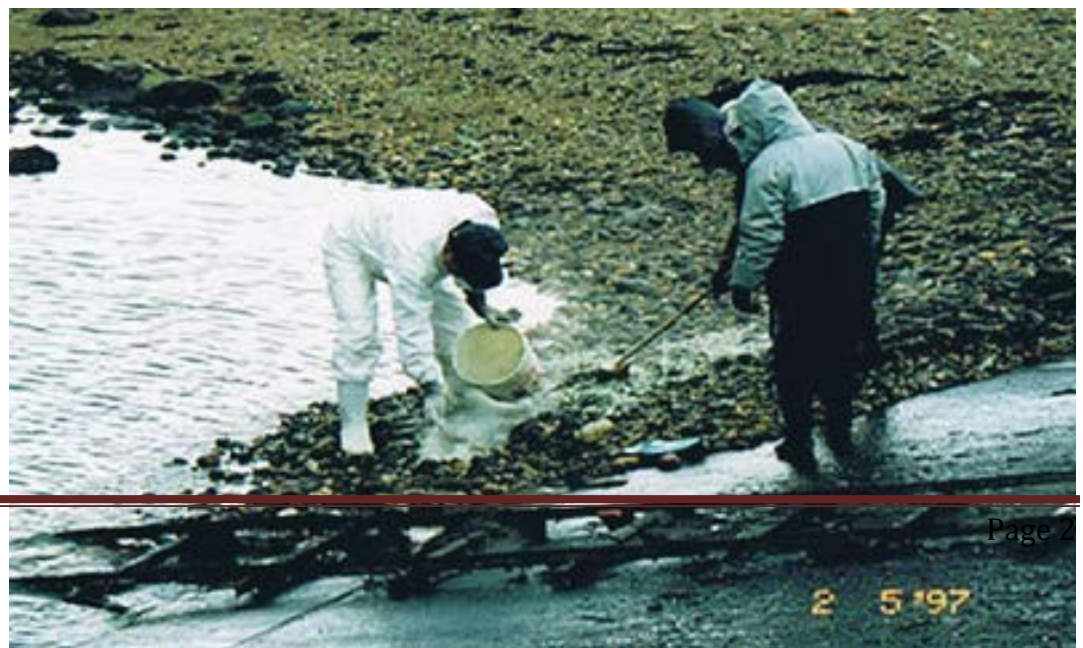
The weather along the coast was highly variable. The weather, during the project consisted of heavy seas and calm seas, rain, sleet, and sun. This affected the water level along the rocks and

beaches would erode the sand during high waves and then return the sand during calm weather. This impact could account for the observed burying of oil on the sand beaches.

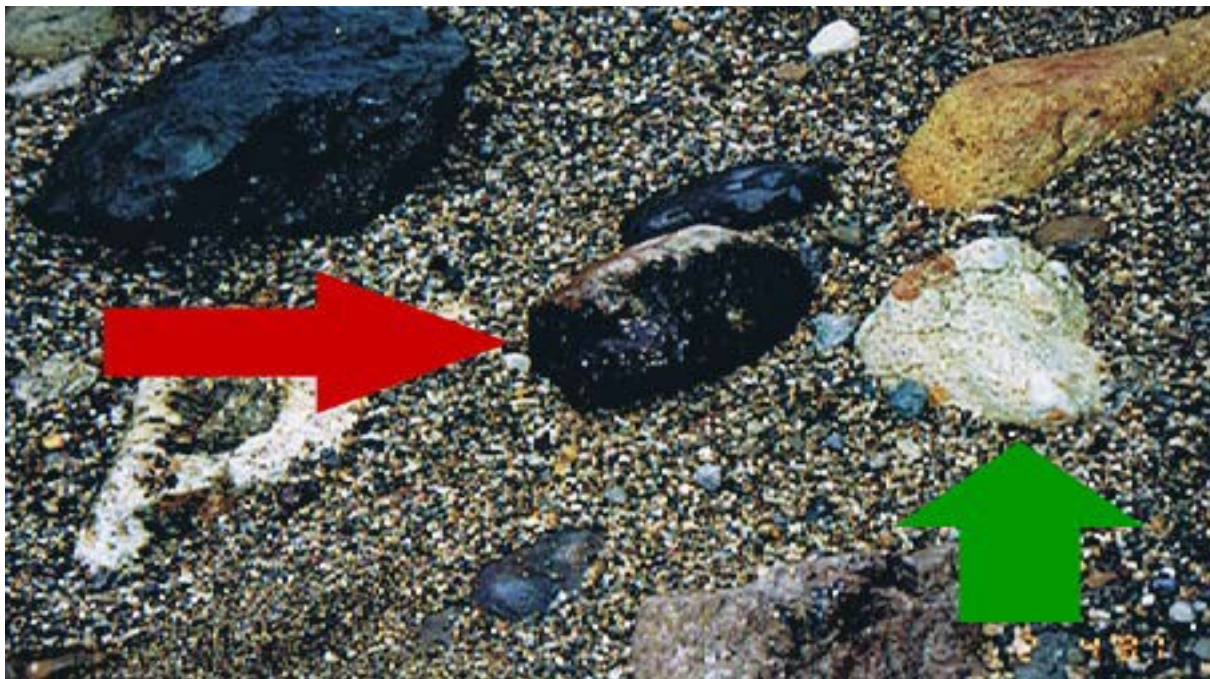
The Rock on the left hand side was left untreated and the rock on the right hand side was treated with

BioZorb®.

Prior to our visit Mr. Kono, Mr. Terakawa and Mr. Takai of the Fuji Packing Company of Osaka, had applied BioZorb to two areas, one on a breakwater and the other on rocks. Video taped daily coverage showed a reduction of thickness of the oil. Visual observation plus the video record confirmed that a reduction of oil was evident

Our first effort was to show the absorptive property of BioZorb®. An oil covered rock was treated with the powder and the resultant oil-powder was washed into sea water, leaving a clean rock surface. The crude oil on people's hands was cleaned by the same process. These observations of oil reduction and cleansing were followed by a general application of BioZorb® in the area.
