# Case Study

## Site Description – Diesel fuel spill under railyard tracks

**Site Location:** Fort Wayne, Indiana

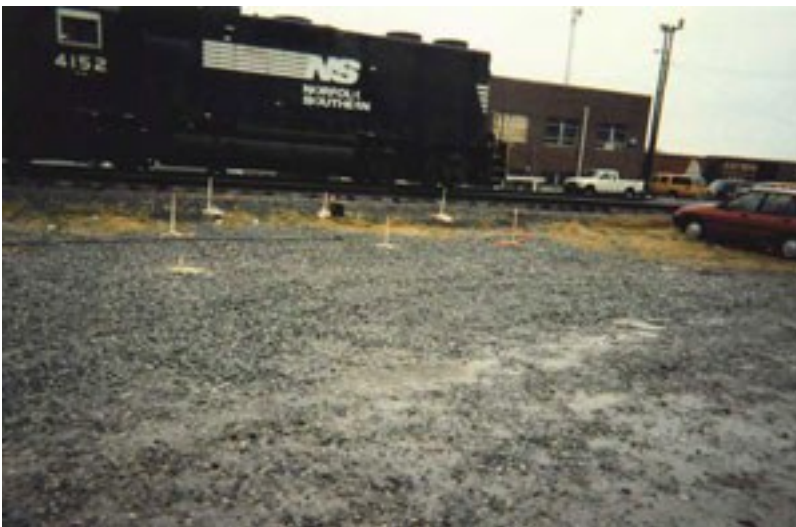
**Photo 1** 10 injections points allowed us to introduce the product with minimal disruptions to trains and road traffic.

To treat the area we developed a matrix that contained 10 injection points. Each of the sites had vertical holes drilled and PVC pipes were put into the hole. The 10 injection points allowed us to use pressure injection and gravity feeds to add microbes to the area.

The Oppenheimer Formula III was introduced into these sites in a slurry form. The slurry was made by mixing the formula with the BioCatalyst, no other products were used.

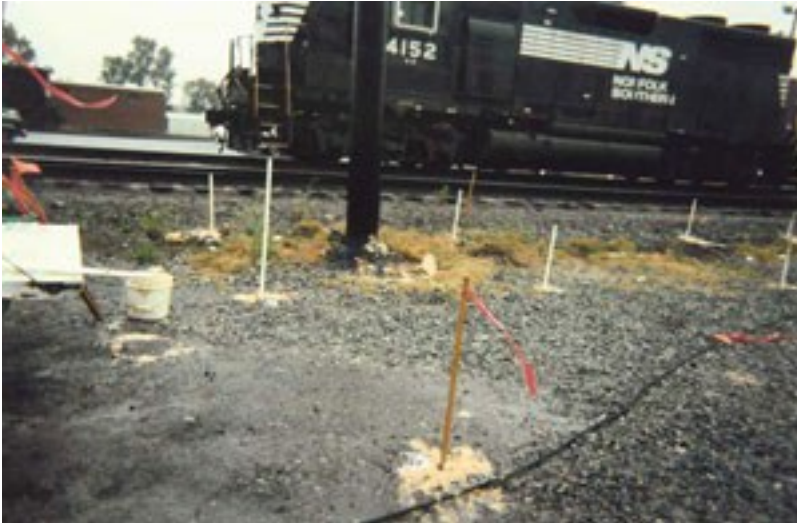
**Photograph 2** Injection points within 4 feet of train tracks as trains pass by.

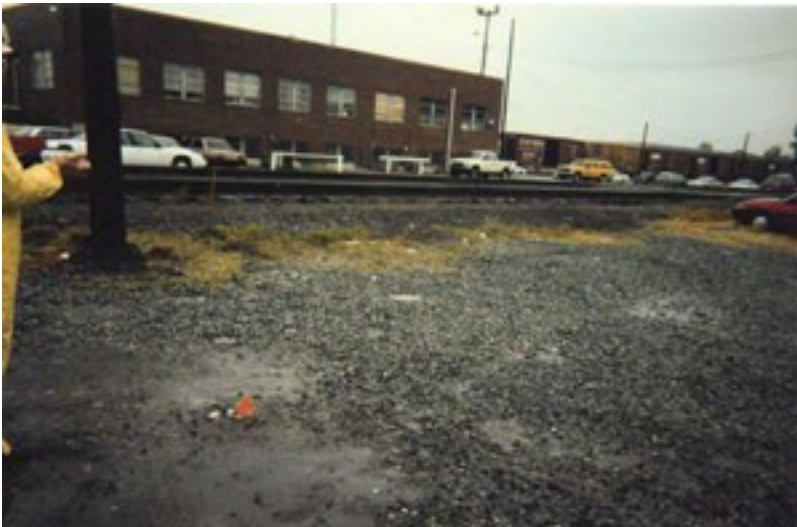
**Photograph 3** After treatment the injection points were left in place but cut off at ground level.

The weather conditions during treatments were mostly raining with temperatures consistently in the mid 50's. After treatment the injection points were cutoff at ground level. This allowed us to monitor the groundwater as well as allow us to re-treat potential hot spots if they arose.
